Update on ETT West Texas Arms Project June 2019

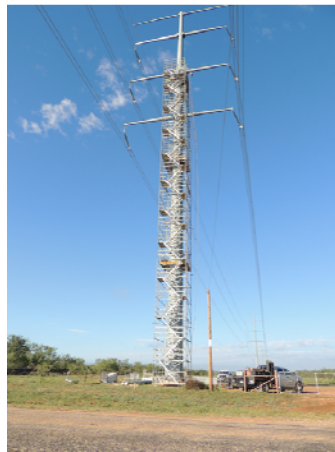
- We are in the clean-up phase of a drone inspection program for the tangent towers on ETT's CREZ lines. The drone program will allow for inspection of lines while they are energized in this cycle and in the future. As defective arms are identified, shorter outages for arm change outs will be required.
- Scaffolding is being deployed for weld repairs for flanges on towers, which improves weld quality, safety and productivity levels. This program has been in place since late August.
